Boost Valve & Sleeve Kits

Sonnax Part Summary

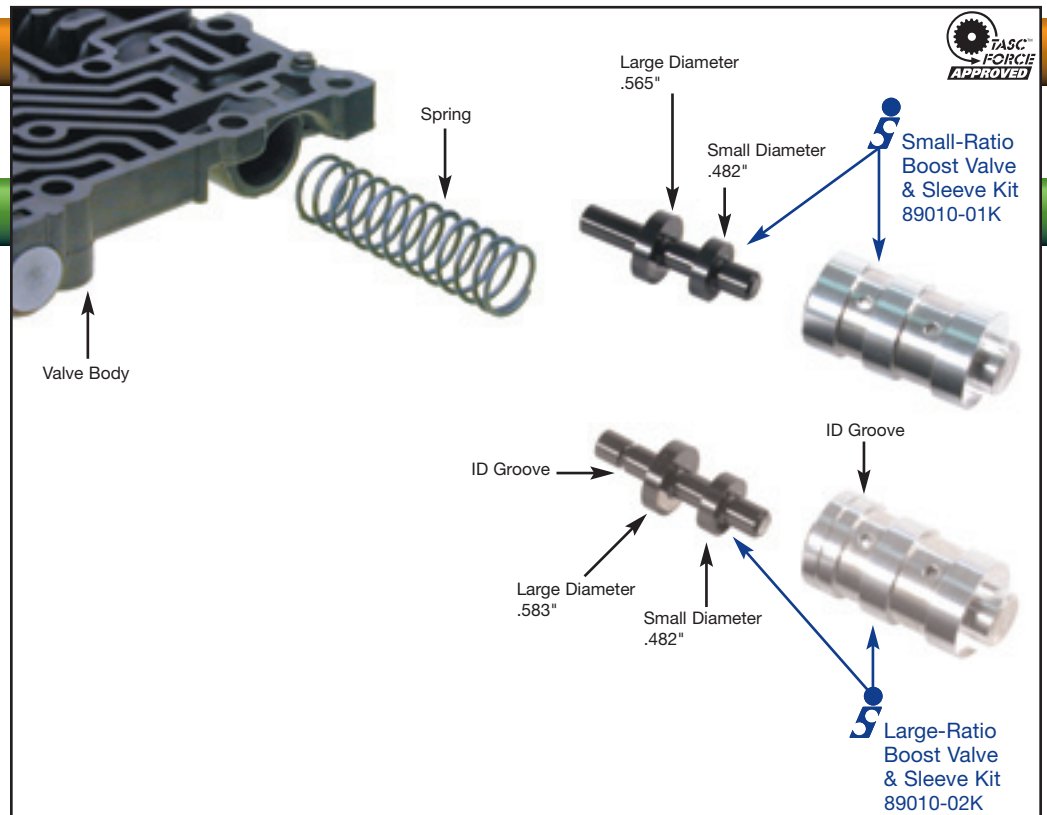
Severe wear of the boost valve assembly allows TV and reverse boost oil leakage.

Toyota vehicles equipped with an A130, A131, and A140 transaxle may exhibit insufficient line rise in the drive ranges and excessively high pressures in reverse. This may be caused by extreme wear of the boost sleeve. Wear allows TV oil to exhaust through the manual valve in drive ranges, and reverse oil can enter the TV circuit forcing the pressure regulator valve into a high pressure position. The Sonnax boost valve and sleeve kits **89010-01K** & **89010-02K** will restore the hydraulic integrity of these circuits by preventing cross leakage.

The closely toleranced replacement boost valve and sleeve restores hydraulic integrity and prevents oil leakage.
