Overdrive Clutch Hub Bushing

The OEM overdrive clutch hub bushings in 41TE and 42LE units are poorly toleranced and allow leakage that can lead to lube exhaust and planetary damage. The Sonnax replacement bushings **92004-L**, **92004-LOS** and **92004-SP** replace the two-piece OEM bushing and provide a more closely toleranced fit.

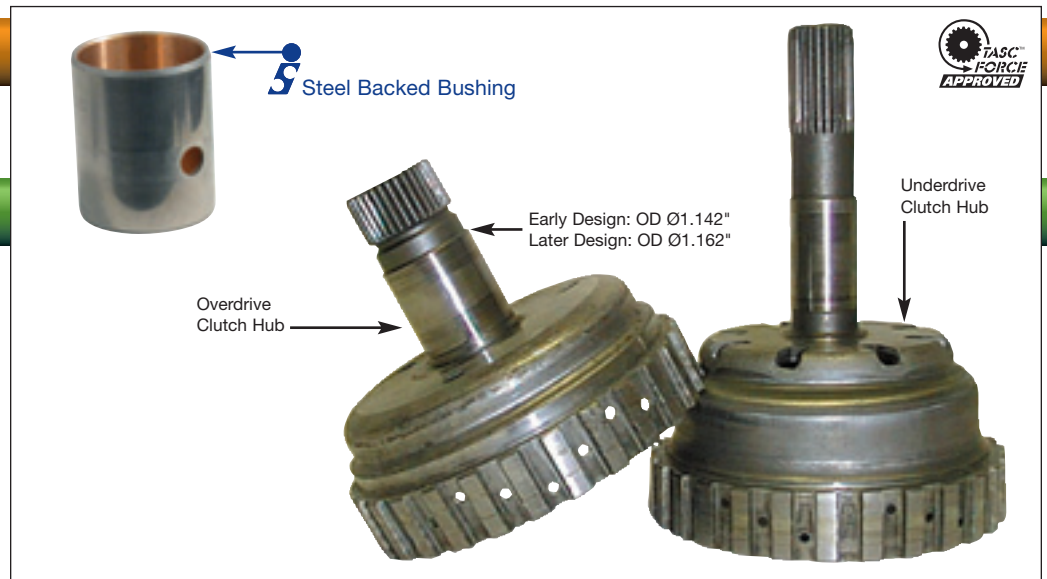
Planetary failure, shaft breakage

Poor tolerancing of the OEM bushings allows critical lube to exhaust.

These unique replacement bushings restore the desired fit with the underdrive shaft to prevent excessive radial movement.

92004-LOS Housing I.D. Size .9410
5 Bushings Late Design

92004-L Housing I.D. Size .9370
5 Bushings Late Design

92004-SP Housing I.D. Size .9590
5 Bushings Early Design
