New Design Low/Reverse Piston Retainer Oil Feed Seal

92106-01K

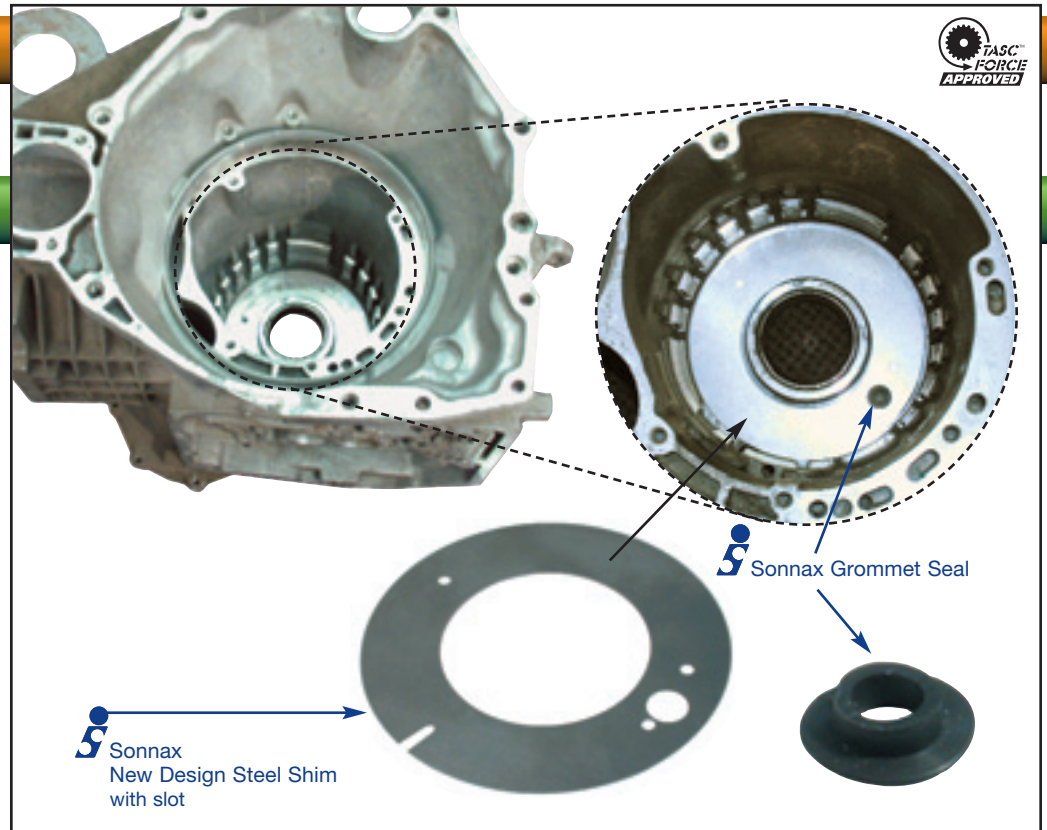
Delayed reverse engagement

- Codes 24 & 60 • High L/R clutch volume index (CVI over 100)

Gasket distortion causes leakage at the low/reverse oil feed.

The root cause of low/reverse oil feed leakage is piston retainer distortion and gasket material relaxing around the clutch feed hole. This prevents a positive seal around the oil feed hole on the piston retainer. The Sonnax steel gasket will not distort. The rubber grommet provides positive sealing at the passage.

Steel shim prevents distortion caused by mounting bolts creating leakage at the feed port.

NOTE: Install this new design steel shim and rubber grommet in place of the original gasket of either design. Do not replace a new-style gasket with an old-style shim.
