## Boost Valve & Sleeve

Saturn TAAT Type 2 valve bodies only

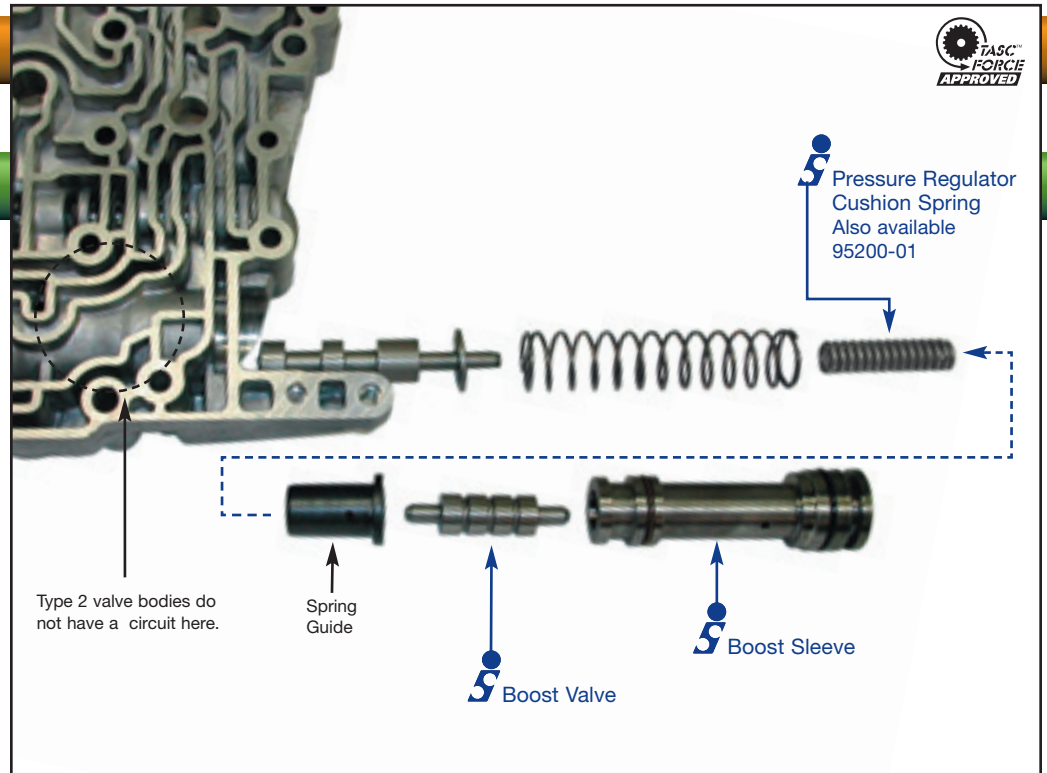
Boost valve assembly wears out.

Poor line rise results when excessive wear occurs in the boost sleeve assembly. This prevents the pressure regulator valve from being stoked to the high line position. Valve wear can also result in the boost valve sticking, causing unintended line rise. Sonnax now offers a direct replacement boost valve and sleeve assembly.

Replace worn boost valve assembly to eliminate oil leakage.
