Manual Valve

96201-05

Sonnax Part Summary

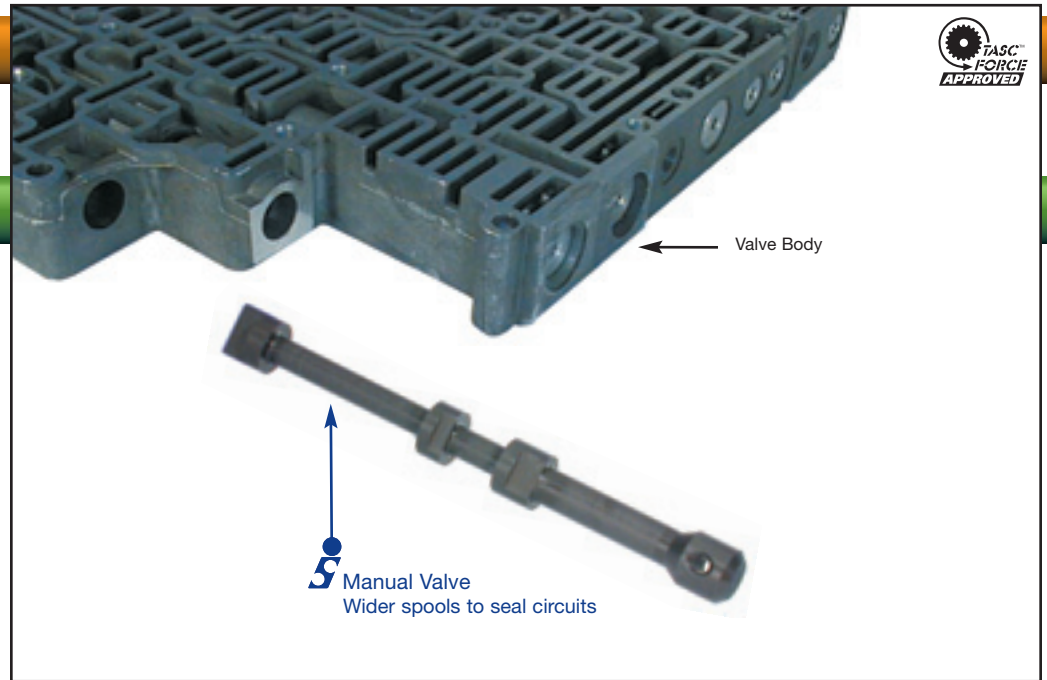
1 Manual Valve

Delayed forward engagement

- Burned forward clutch

Wear at the valve body bore allows oil to exhaust or cross leak.

Delayed forward engagement, burned forward clutch, and/or forward clutch psi low by 10-15 psi in vehicles with AXOD, AXODE, AX4N/S or 4F50N transmissions are common complaints. These are often caused by a worn valve body at the manual valve bore, allowing excessive oil leakage. Replace the worn OEM manual valve with Sonnax manual valve **96201-05** to prevent oil leakage and increase stability at the linkage.

This modified manual valve has lengthened spools for reduced leakage and better stability within the bore and at the linkage.

- Manual valve is hard-coat anodized to prevent wear.
- The three spool diameters have been lengthened to provide increased stability and prevent oil leakage.
- Exhaust flats added to the extended spools provide proper oil circuit control.
- Lengthened spools and tightly toleranced cross hole provide increased valve stability at the linkage.
