Bypass Clutch Control Sleeve & Plunger Valve

96201-06K

Sonnax Part Summary

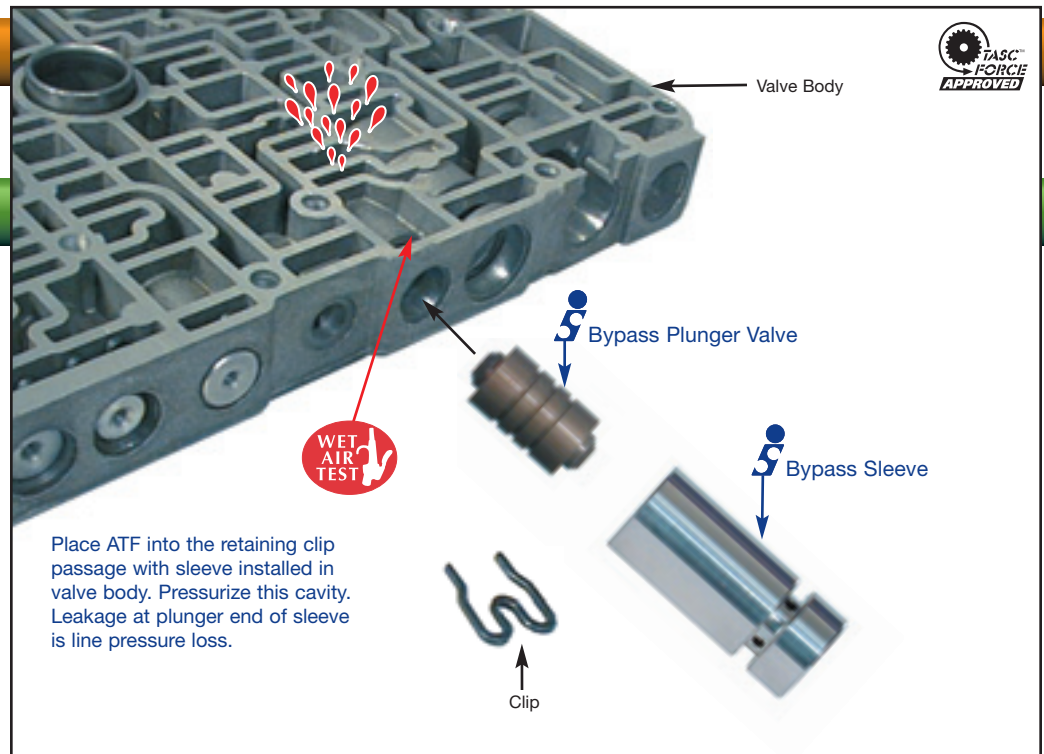
TCC apply and release problems, Code 628

- Reduced cooler and lube pressure

Severe wear of the bypass clutch control plunger valve sleeve.

This tightly tolerated bypass clutch control sleeve and plunger valve are designed to prevent wear.
