Reverse Boost Valve & Sleeve Kits

Sonnax Part Summary

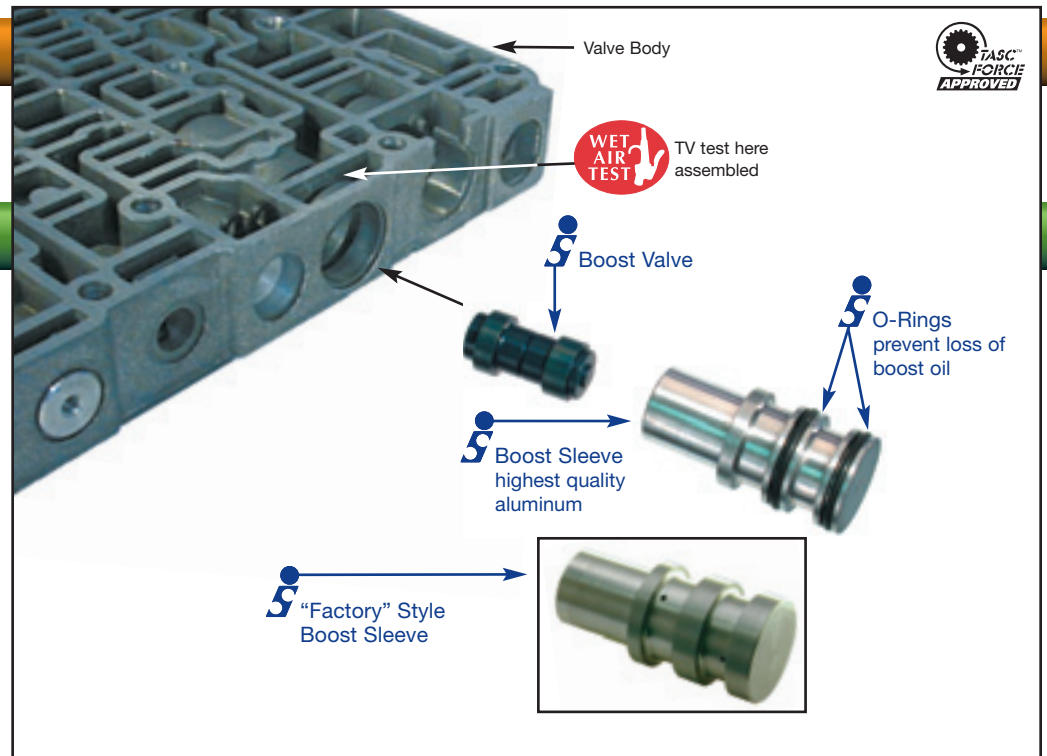
Flare 1-2 or 2-3 upshifts, non-adjustable (high) throttle pressure

• 2-1 downshift clunk • Harsh reverse • Clutch/band failure

The boost valve wears the inside diameter of the boost sleeve, allowing TV/EPC and reverse oil leakage.

These replacement assemblies provide wear-resistant materials, minimum clearance for restored pressure control, and optional o-rings for positive sealing within the bore.
