## Reverse Boost Valve & Sleeve Kits

### Sonnax Part Summary

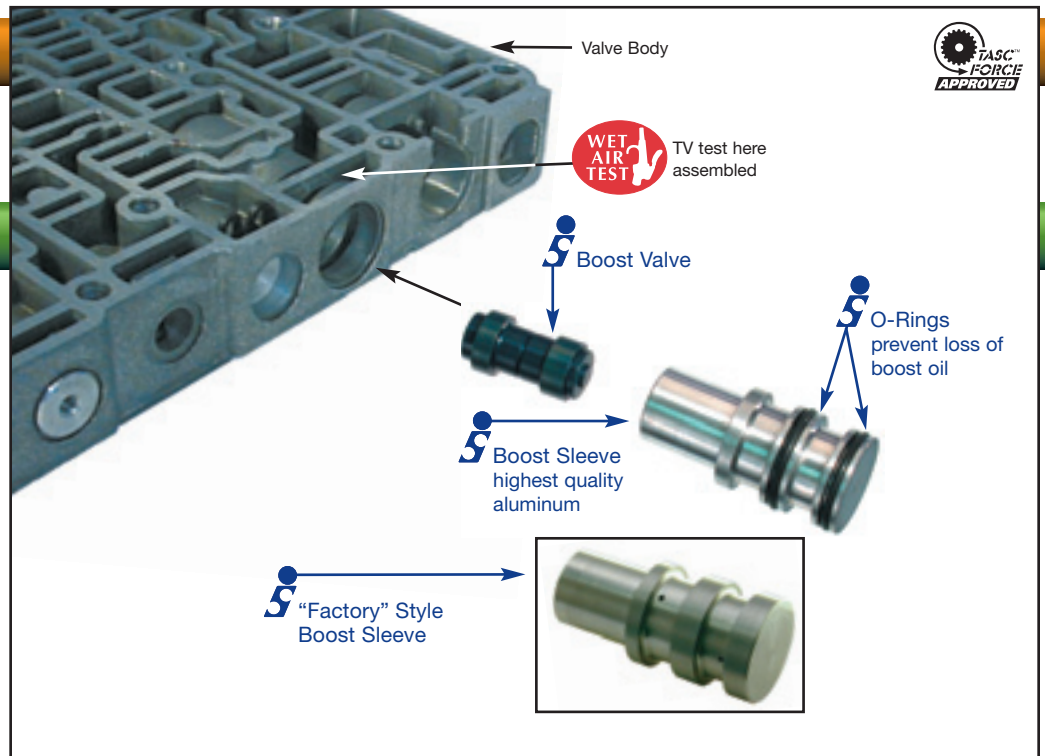
The boost valve wears the inside diameter of the boost sleeve, allowing TV/EPC and reverse oil leakage.

These replacement assemblies provide wear-resistant materials, minimum clearance for restored pressure control, and optional o-rings for positive sealing within the bore.
