Valve Saver Cap

96201-15K

Sonnax Part Summary

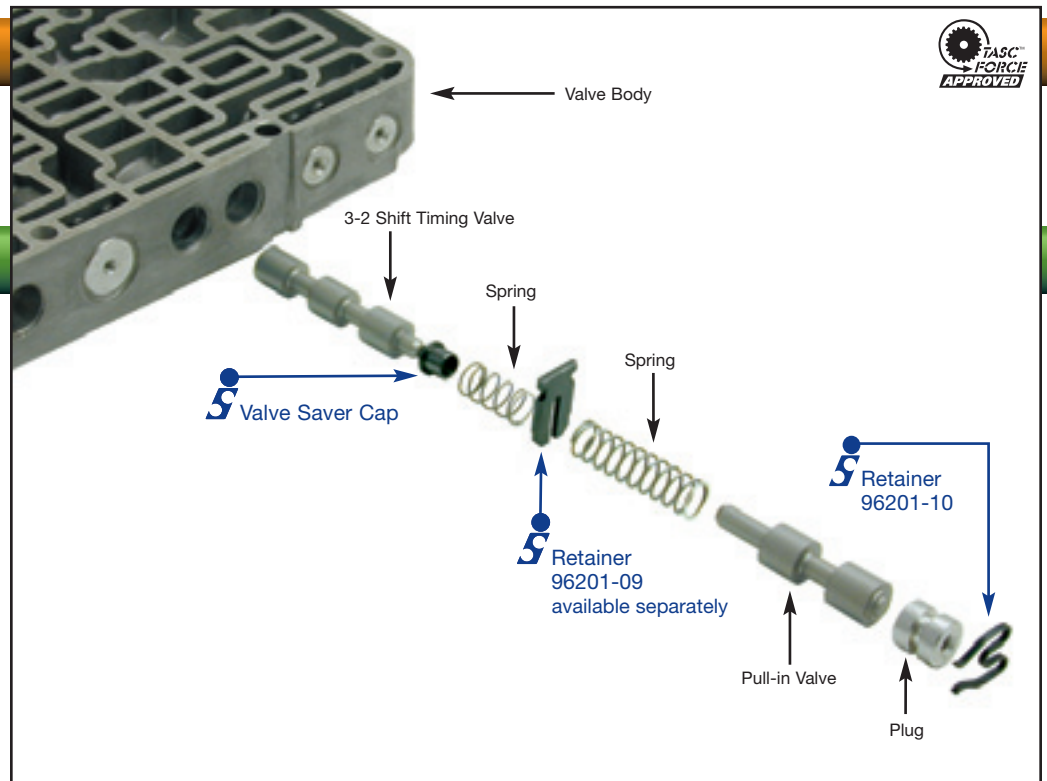
No upshift, 3-2 coastdown neutral

The valve constantly bangs the clip, resulting in broken clips that get lodged and sometimes damage the end of the valve.

Continuous banging of the 3-2 shift timing valve spring stem against the steel retainer results in damaged valves and/or broken retainers. Sonnax has designed a valve saver cap and retainer kit, 96201-15K, to salvage a damaged 3-2 shift timing valve.

This valve saver cap and retainer clip allows reuse of the 3-2 shift timing valve, and prevents future damage.

- Steel end cap allows valve salvage and prevents future damage.
- Replacement retainer also included.
