Bypass Clutch Control Sleeve & Plunger Valve

96206-01K

Sonnax Part Summary

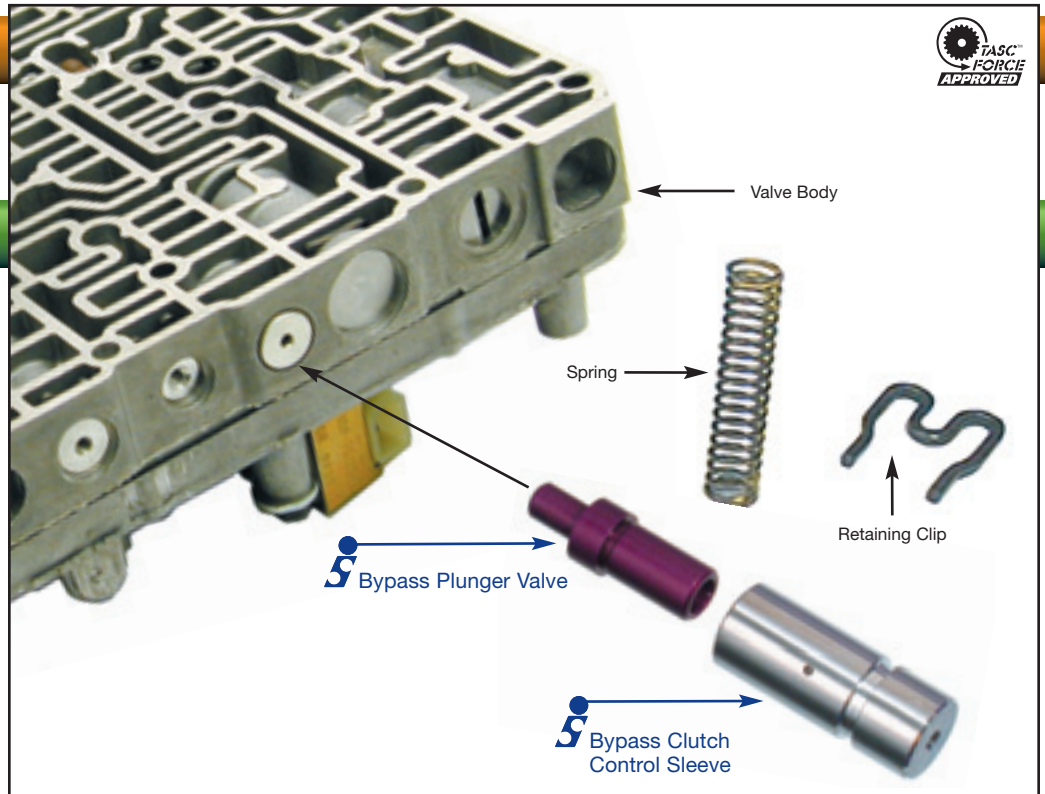
Excessive cooler circuit oil loss

• No or soft TCC apply • TCC slippage • Code 628 • No TCC release during coast

Excess wear at the bypass clutch control sleeve allows regulated converter charge and cooler oil leakage.

Vehicles with an AXOD & E or AX4S transmission frequently have lube system failures, as well as torque converter clutch apply and release problems. These complaints can be aggravated by severe wear of the bypass clutch control plunger sleeve. Excess wear allows regulated converter charge and cooler oil leakage. This oil is fed to the lube circuits, cooler, TCC and into the sleeve to help maintain the TCC in the release position. If the sleeve is worn, oil will exhaust past the plunger sleeve. Because this regulated converter charge oil is always present, either as release or apply pressure, severe leakage at the sleeve can result in a no TCC apply situation. Sonnax offers a tightly toleranced bypass clutch control sleeve and plunger valve, **96206-01K**, that restores hydraulic integrity and eliminates the above problems.

Restore hydraulic control and prevent cooler/lube oil loss by installing this upgraded assembly.

- Precision sleeve is manufactured from high-quality aluminum to minimize wear.
- Aluminum plunger valve has been hard-coat anodized to resist wear.
- Sleeve has been lengthened to prevent oil loss.
