Accumulator Bore Sleeve Kits

Sonnax Part Summary

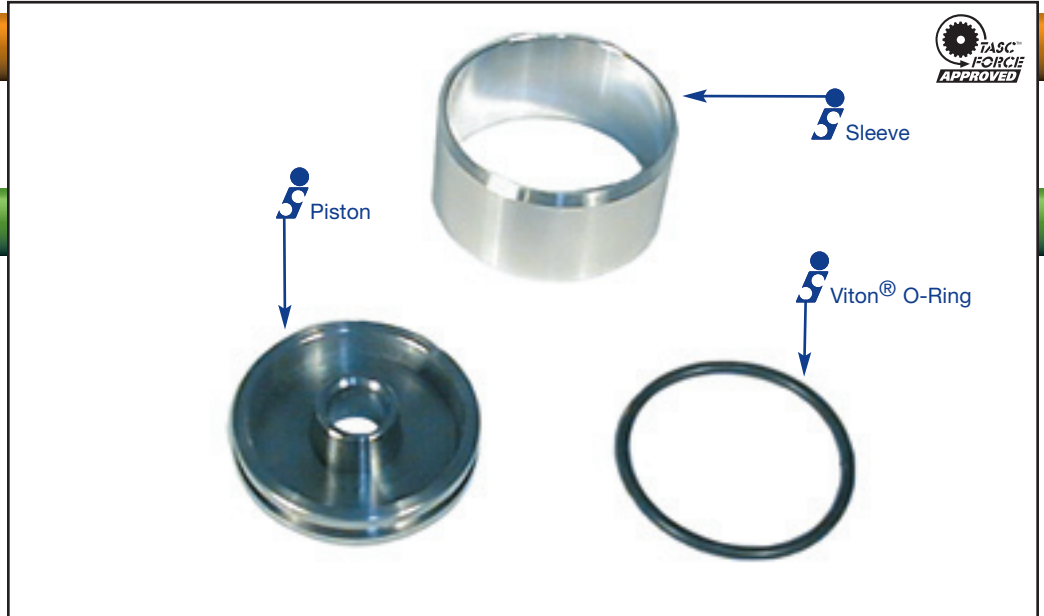
Scored accumulator bores create loss of clutch pressure or cross leaks.

The accumulator bores on AXOD & E, AX4S channel castings can become scored, which creates loss of clutch pressure or cross leaks. The continuous oscillation of the piston within the bore causes excessive wear. Also a broken accumulator spring can get caught between the piston and the bore causing a deep groove in the casting wall. You can resolve these problems by installing these Sonnax AXOD & E, AX4S accumulator bore sleeve kits.

The accumulator bore sleeves are made from wear-resistant aluminum and the length of the piston-to-pin contact area has been increased to reduce piston cocking and increase sealing surface area.

- Kits contain an aluminum sleeve and new steel accumulator piston with a Viton® o-ring.
- Piston is compatible with all OEM springs and OEM piston pins.
- Length of piston-to-pin contact area has been increased to reduce piston cocking and increase sealing surface area.
- Kits available for N-D, 1-2 and 3-4 locations, along with a master kit that contains all three.
