## Low/Intermediate Upgraded Servo, Spring, Pin & Retainer Clip

### Sonnax Part Summary

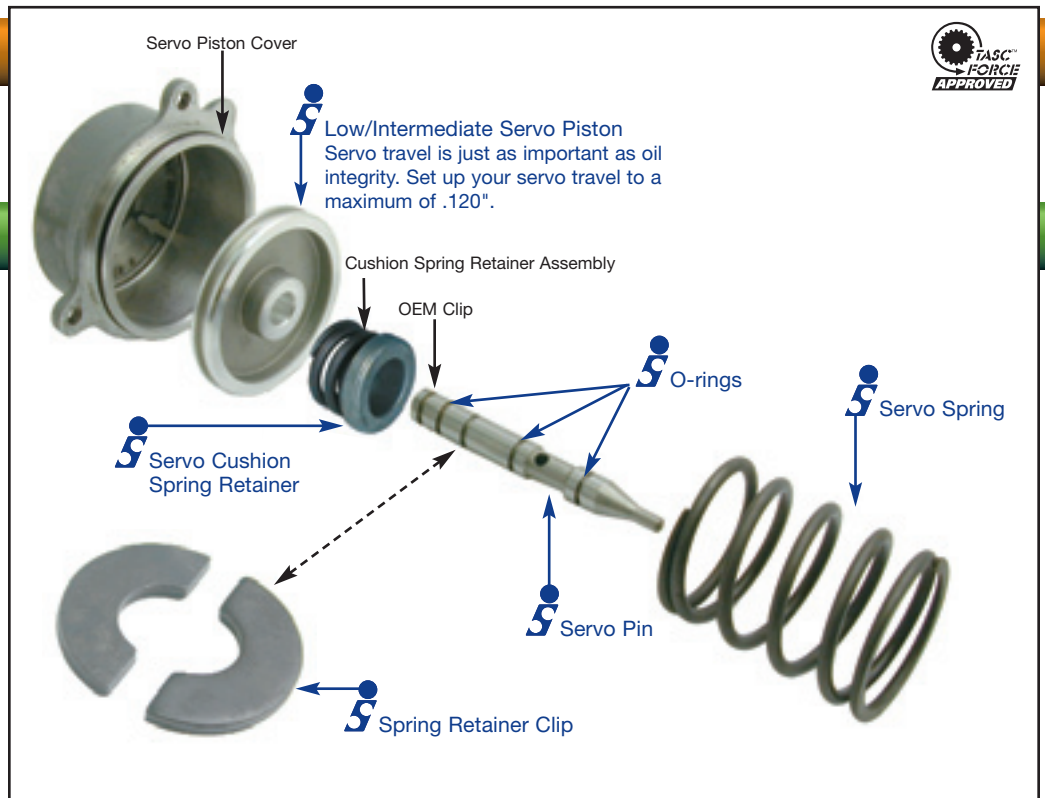
## Delayed forward engagement

- Poor servo timing • Downshift clunk • 2-3 shift flair

Servo pin-bore leakage, incorrect spring calibration, case bore leakage at pin, and broken parts.

Some common complaints with AXOD & E and AX4S transmissions are delayed forward engagement, poor servo timing, downshift clunk, 2-3 shift flair, a broken servo retaining clip causing 3-2 neutral, and a broken servo cushion spring retainer. Sonnax now offers five upgraded products to correct the complaints: a low/intermediate servo piston **96728**; servo cushion spring retainer **96728-01**; servo spring **96995A**; servo retaining clip **96945R**; and servo pin **96945S**.

The replacement servo corrects leakage at the pin bore, the modified spring rate provides better servo timing, and the servo pin has o-rings for positive sealing.

- Replacement servo piston eliminates leakage at the pin bore.
- Updated spring is longer and has a spring rate approximately 12 lbs. lighter than the OEM, reducing delayed forward engagements.
- Spring eliminates downshift clunk complaints because it is stiffer than the common Chrysler replacement spring.
- Updated servo spring retainer clip is made of hardened steel for better wear resistance and has full contact on the pin groove radius, preventing breakage of the OEM clip.
- Replacement servo pin incorporates 3 o-rings for positive sealing and leakage prevention.
- Replacement servo cushion spring retainer not available from OEM.
