## Ring Gear Retaining Ring

96730-RR

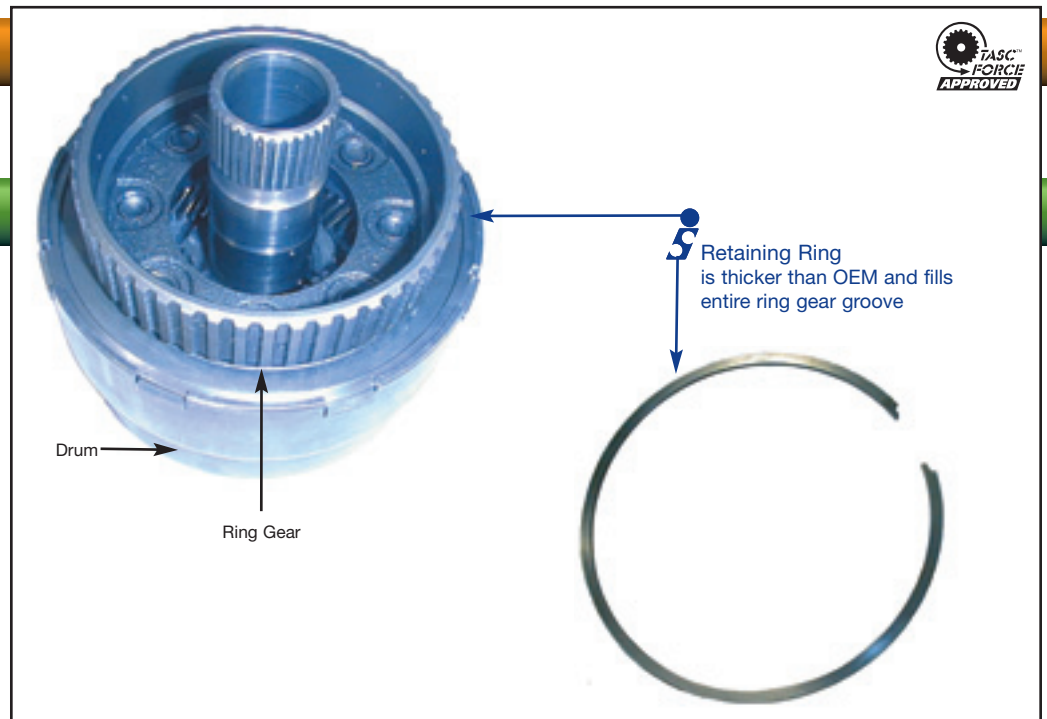
- Retaining ring becomes loose and pops out

OEM retaining ring does not fill groove axially, allowing it to pop out.

A common complaint in vehicles with AXOD & E, and AX4S transmissions is that the retaining ring securing the front and reverse planetary assemblies into the rear ring gear becomes loose and pops out. This can result in no movement situations. This is often due to a retaining ring that is too thin axially, which allows excessive clearance within the rear ring gear groove, causing it to flex and pop out. Install the Sonnax AXOD & E Rear Ring Gear Retaining Ring **96730-RR**.

This retaining ring is thicker and fits more securely in the groove, eliminating excess clearance that leads to the ring popping out.
