## Channel Plate Repair Sleeve

96803

### Sonnax Part Summary

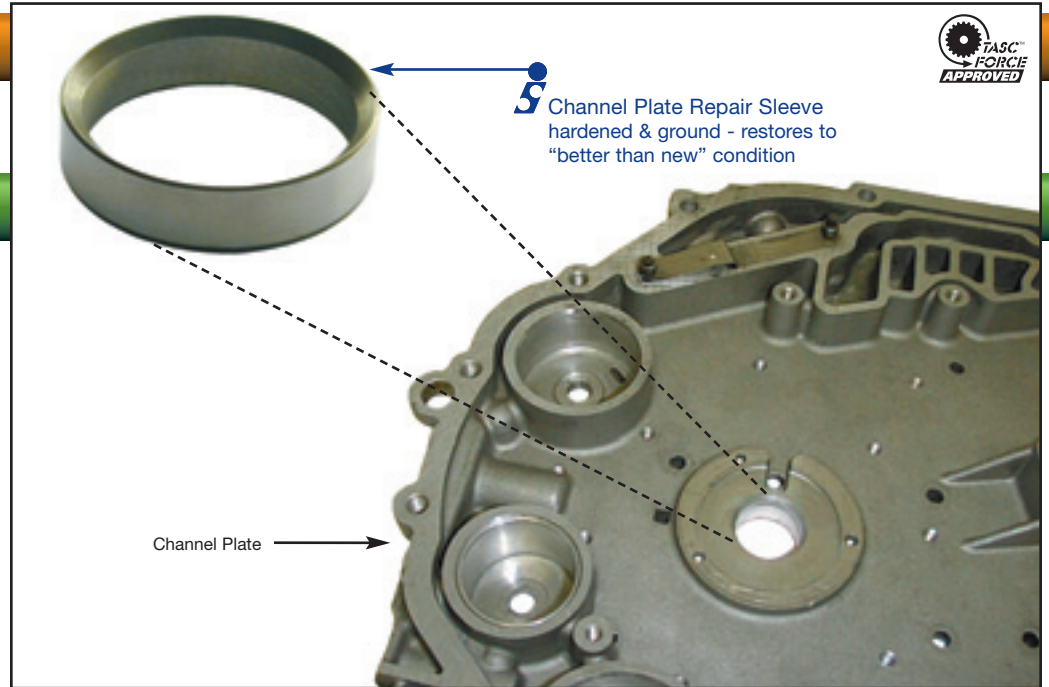
No cooler flow , delayed forward

- Internal leakage
- Lost lubrication oil to planetaries

The turbine seal ring wears on the soft aluminum channel casting surface.

The cast iron sealing ring on the Ford AXOD & E, AX4S, AX4N AND 4F50N turbine shaft frequently wears the mating surface on the aluminum channel plate. The resulting internal leakage diminishes cooler/lube flow, which contributes to common overdrive planetary failure. Hypoeutectic aluminum castings have insufficient silicon content to withstand the erosive wear of ductile iron. Sonnax has made available a hardened and ground steel sleeve **96803** to salvage worn channel plates.

This hardened and ground steel sleeve salvages worn channel plates.

**Note:** This repair sleeve requires machining.
