Low/Intermediate Upgraded Servo, Spring, Pin & Retainer Clip

Sonnax Part Summary

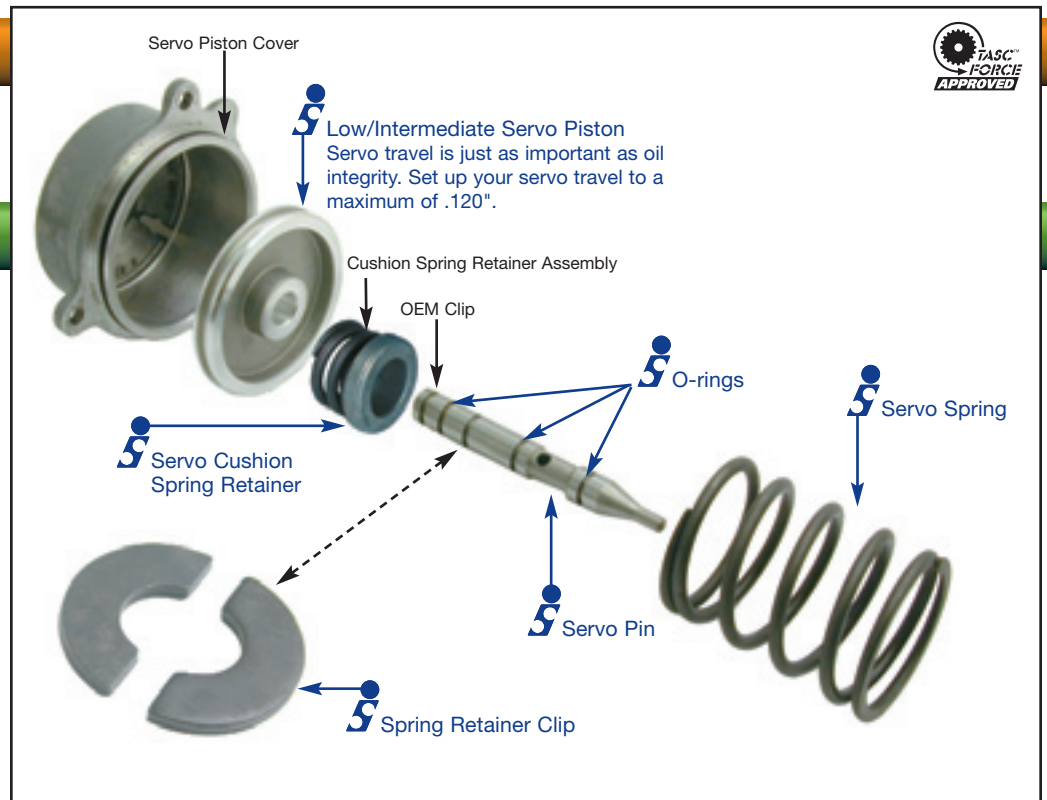
Delayed forward engagement

• Poor servo timing • Downshift clunk • 2-3 shift flair

Servo pin-bore leakage, incorrect spring calibration, case bore leakage at pin, and broken parts.

The replacement servo corrects leakage at the pin bore, the modified spring rate provides better servo timing, and the servo pin has o-rings for positive sealing.
