**Poor or erratic 2nd gear shift**

**Bushing**

**120002**

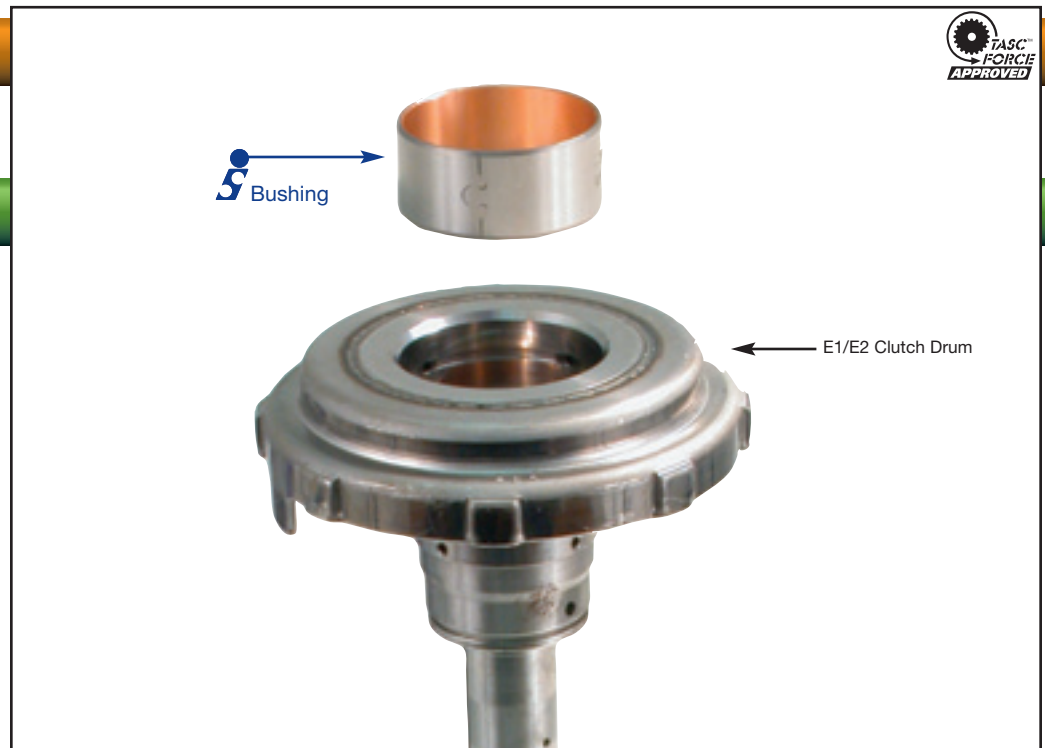
1 Standard Bushing

OEM replacement bushings can allow critical line pressure to exhaust because of poor fit. This line pressure feeds the E2 clutch and provides critical lube. When the bushing is worn or incorrectly toleranced, it will result in poor or erratic 2nd gear shifts, burned clutches and loss of lube. The Sonnax replacement bushing **120002** is designed to provide the proper clearance for this application.

- Bushing is constructed from durable steel backed aluminum for better wear resistance than the OEM bushing.
- Bushing is precision machined to provide the correct clearance with the mating shaft.

Replace the E1/E2 clutch drum bushing with this tighter-fitting bushing.

**Note:** The Sonnax bushing is designed to maintain minimal clearance between the bore and the mating shaft to greatly enhance the life of the bushing. As a result, there may be situations where the mating shaft and bushing don't fit due to some small interference. In this instance you may carefully polish the bushing bore with fine emery cloth or a fine abrasive hand pad until the shaft fits in the bushing.
