Clutch Apply Control Plunger Valve & Sleeve Kit

57917E-05K

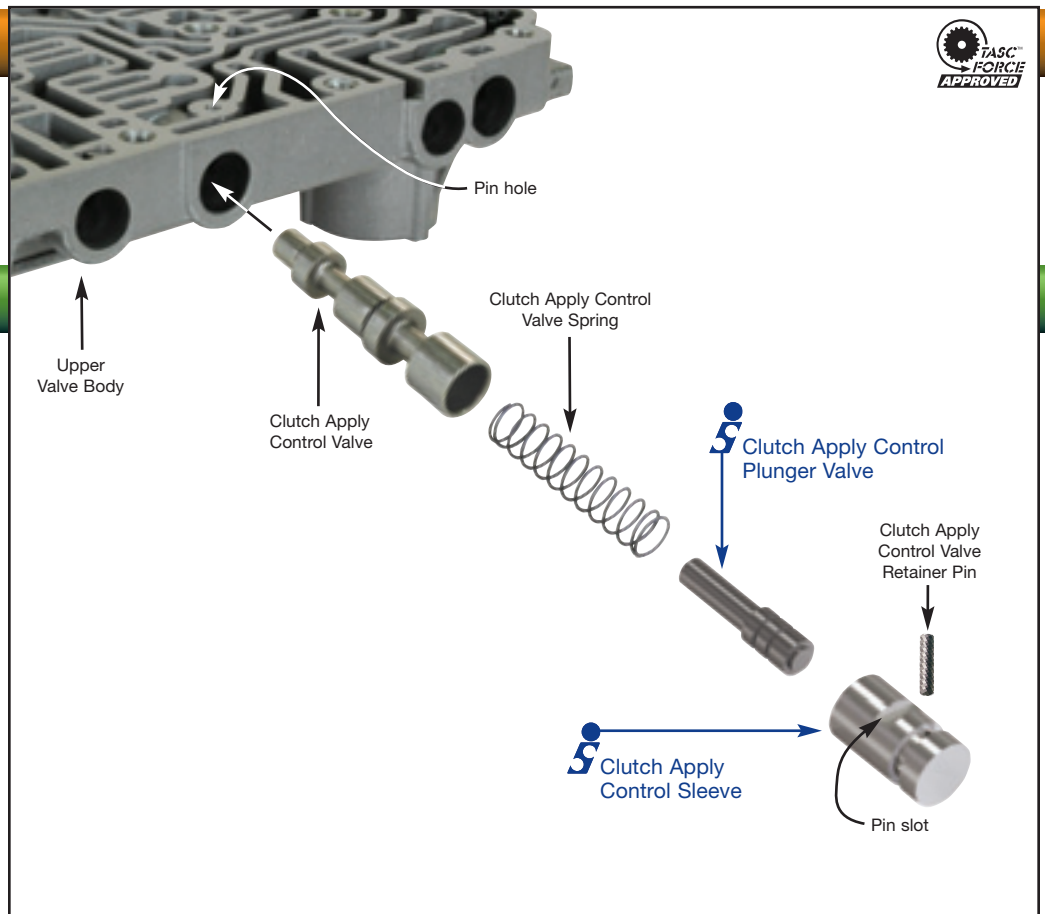
- 1 Clutch Apply Control Plunger Valve
- 1 Clutch Apply Control Sleeve

- The Sonnax sleeve is manufactured from highly wear-resistant billet aluminum.
- The Sonnax valve has been manufactured from hard-coat anodized aluminum to prevent wear.
- Annular grooves have been added to the valve to prevent sidelading related wear.

Continuous oscillation of the steel clutch apply control plunger valve wears the cast-aluminum sleeve bore, allowing clutch apply pressure to exhaust and preventing proper control of the clutch apply control valve.

The tightly tolerated, drop-in replacement Sonnax valve and sleeve assembly restores proper hydraulic clearances and uses upgraded materials to prevent wear.
