Oversized Accumulator Pin & Reamer

Sonnax Part Summary

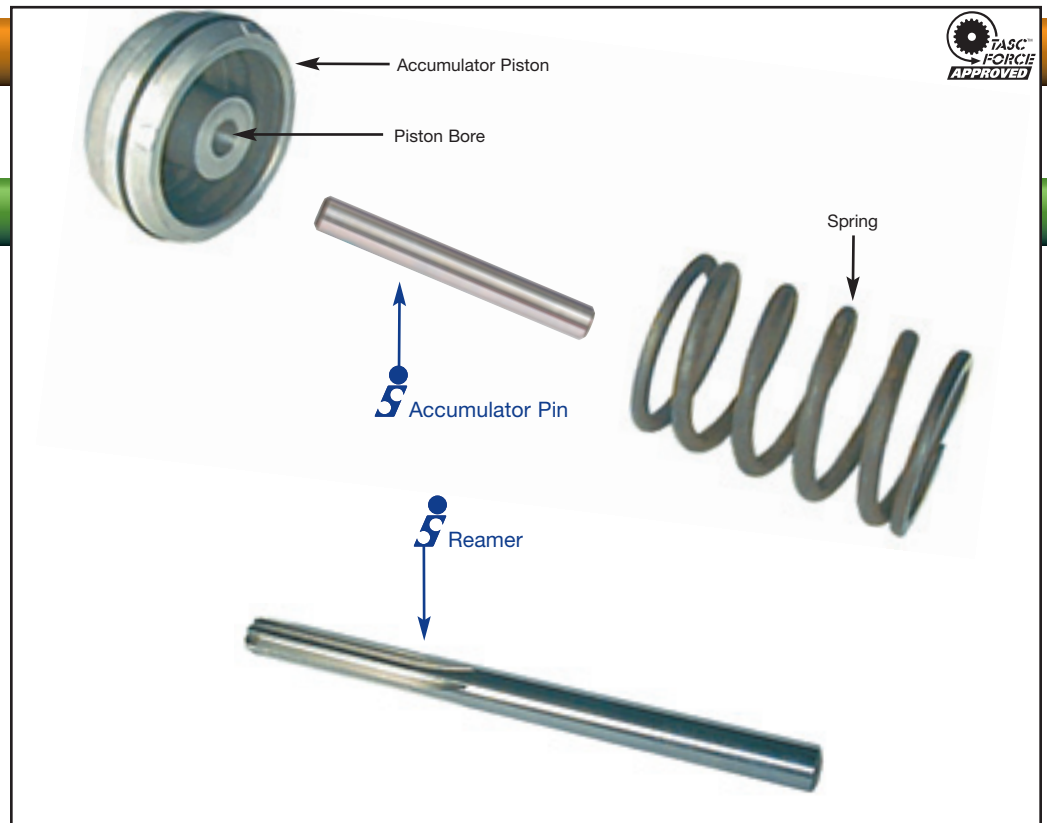
Wear of the accumulator pin and piston creates cross leakage of D-4 oil.

Accumulator pin and piston wear in 4T60 & E and 440-T4 units creates cross leakage of D-4 oil, causing 2nd and 4th clutch failure. Sonnax has designed an oversized pin **84573-01K** to overcome cross leakage.

This oversized accumulator pin and reamer obtain a good hydraulic seal and improve 2nd and 4th clutch apply by reaming and reusing the worn, original piston with the oversized pin.

- Oversized pin creates a good hydraulic seal with the original piston.
- A starter kit **84573-02K** includes a reamer for boring out the original piston pin bore.
- Improves 2nd and 4th clutch apply.
- Salvages accumulator pistons.
