COMPLAINT

Low line pressure

Line Pressure Regulator Valve Cushion Spring

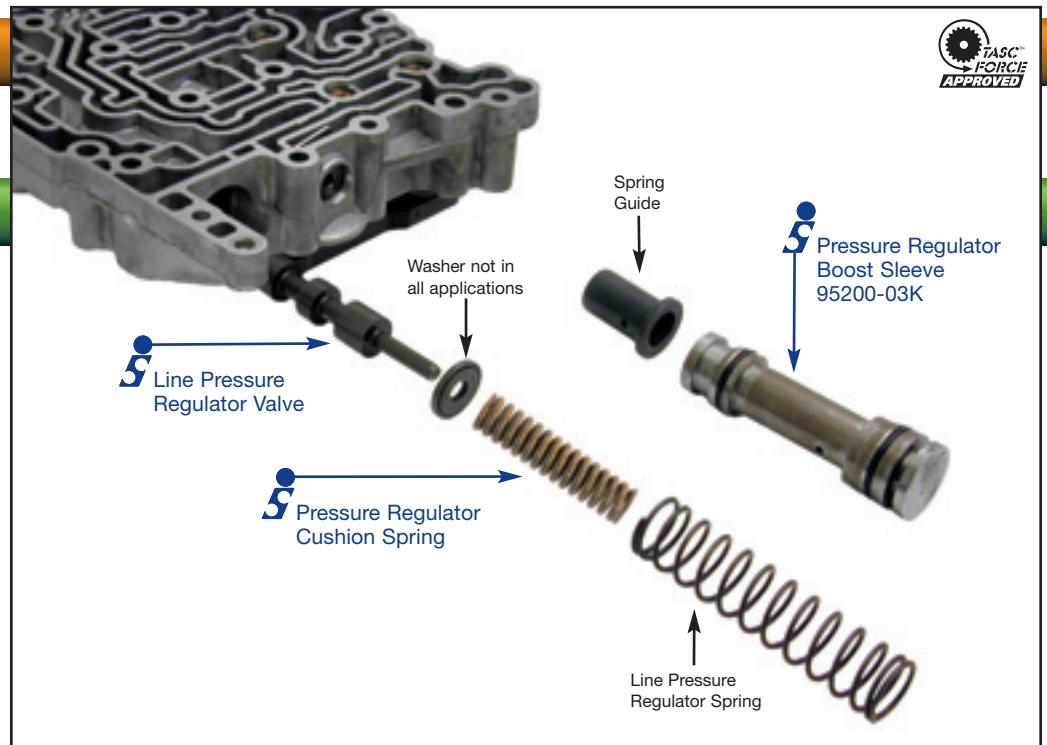
A broken line pressure regulator valve cushion spring.

The line pressure regulator valve cushion spring commonly breaks, resulting in low line pressure. Replacing the broken spring with Sonnax's spring **95200-01** eliminates the need to replace the upper valve body. While the operating environment is severe for a spring of this size, Sonnax's material minimizes the chance of breakage.

95200-01 Fits Type 1 or Type 2
1 Cushion Spring valve bodies

- Cushion spring made from rugged chrome-silicon alloy to provide high allowable working stresses.
- Salvages costly valve bodies.
