TF-80/81SC

PART NUMBERS 39741-22K, F-39741-TL22

B1 Band Control Valve Kit

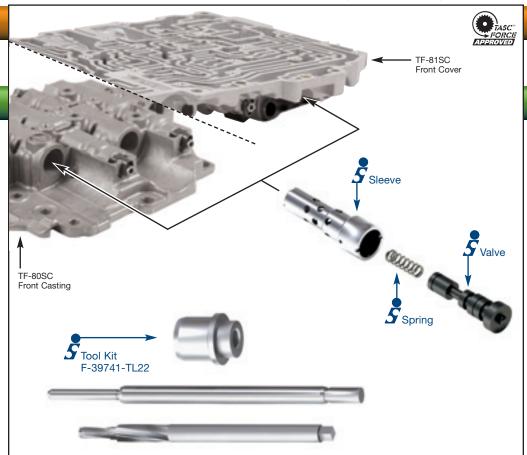
Harsh downshifts, Flare on 1-2, 2-3, 5-6 upshift, B-1 band distress

Wear at the B1 band control valve bore affects apply and release rate of the servo.

The replacement Sonnax sleeve and valve corrects circuit pressure loss and restores control of band apply and release.
