Solenoid Modulator Valve Kit

57917E-13K

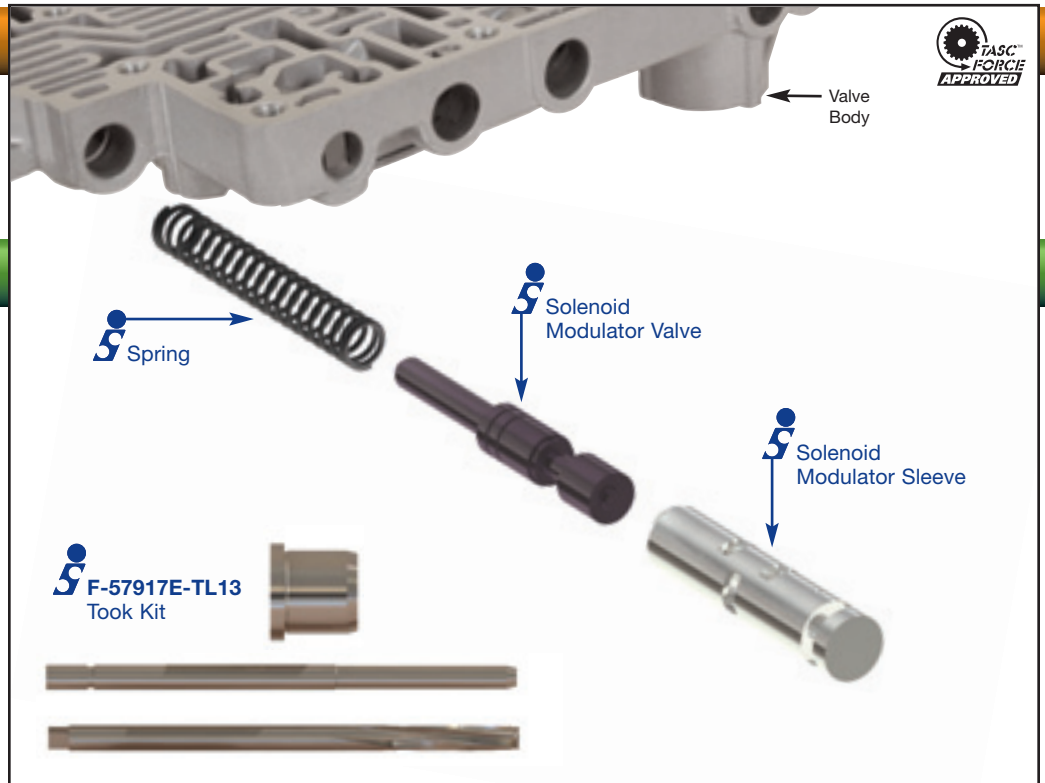
Excessive solenoid pressure is caused by line pressure side-loading the steel solenoid modulator valve and the continuous oscillation of the valve, which wears the cast aluminum bore.

The modified valve and high-grade aluminum sleeve allows the bore to be refurbished, and prevents side-loading of the valve and future wear.

- 1 Solenoid Modulator Valve
- 1 Solenoid Modulator Sleeve
- 1 Spring
