Oversized Manual Valve

68942-16

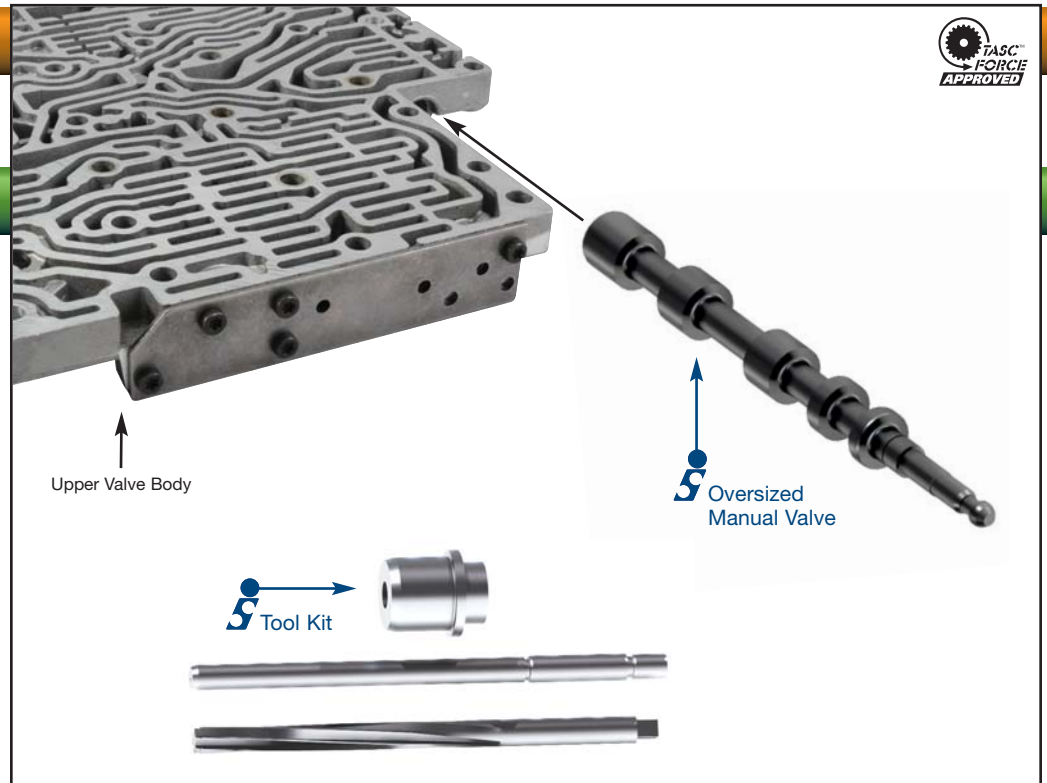
Reduced line pressure, delayed drive/reverse engagement

Valve and/or bore wear due to linkage side loads and/or extended service life.

Ream the bore oversize and install the new Sonnax oversized manual valve.
