## AFL Valve & Sleeve Kit

### 72854-01K

### 72854-TL

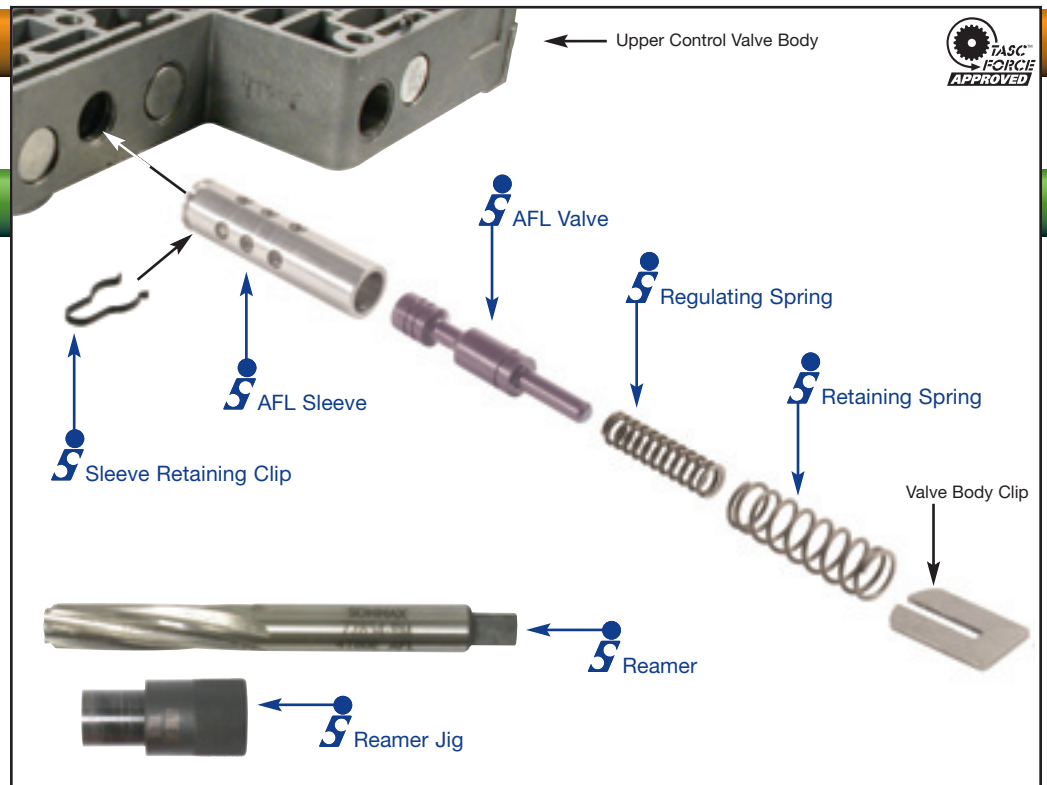
- 1 AFL Sleeve
- 1 AFL Valve
- 1 Regulating Spring
- 1 Retaining Spring
- 1 Sleeve Retaining Clip

- 1 Reamer
- 1 Reamer Jig

The OEM actuator feed limit (AFL) valve routes regulated line pressure to the pressure control and shift solenoids. AFL pressure feeds the pressure control solenoid, which regulates the outgoing torque signal pressure. AFL pressure is directed to the shift solenoids to oppose spring force and stroke the shift valves. Constant oscillation of this hardened steel valve causes the cast aluminum bore to wear, reducing the AFL oil pressure, which can cause solenoid and ratio codes, clutch/band failure and harsh shifts. Bore wear can also cause the valve to stick in the exhaust position, resulting in 2nd gear starts and low line pressure. The Sonnax kit **72854-01K** re-establishes the hydraulic integrity of the circuit by eliminating and preventing wear in the AFL circuit.

- Kit includes a highly wear-resistant aluminum sleeve to provide more durability.
- Hard-coat anodized valve reduces wear and provides better leakage control during thermal expansion.
- Valve spools have been lengthened to provide better stability and prevent leakage.
- Annular grooves have been added to center the valve and prevent wear from side loading.
- A regulating spring has also been added to fit into the lengthened valve and set the correct limiting pressure.
