Bushing failure and/or reverse clutch drum journal damage

Reverse Clutch Drum Sleeve

73300-01

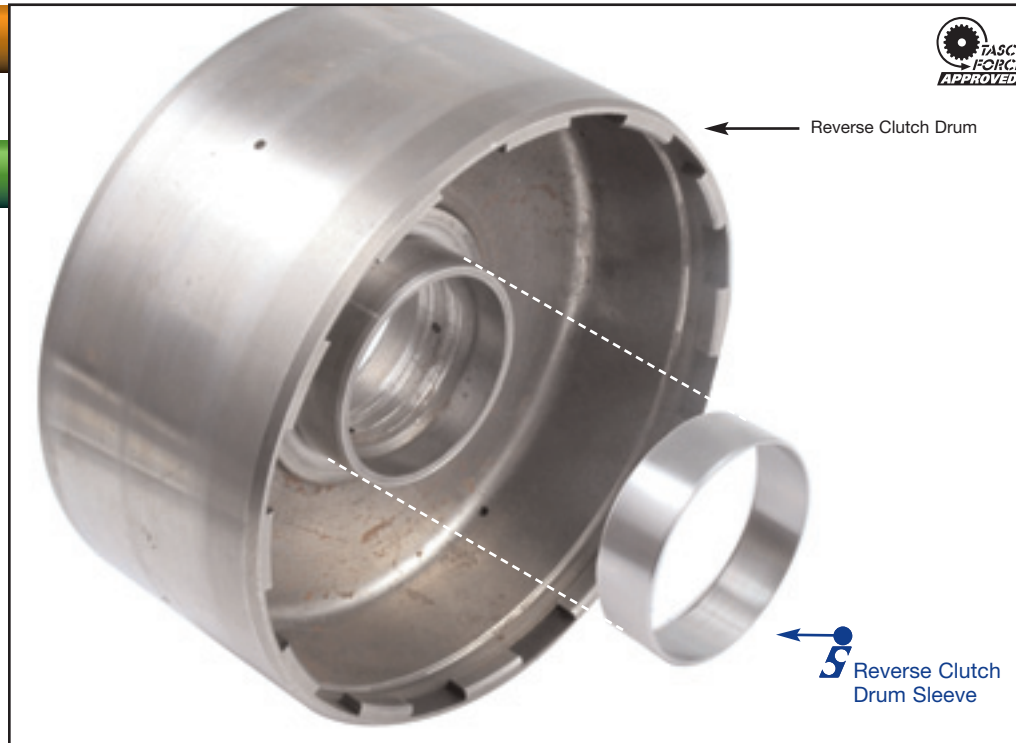
A soft reverse clutch drum journal.

1 Reverse Clutch Drum Sleeve

A soft reverse clutch drum journal can cause bushing failure and/or reverse clutch drum journal damage in CD4E, LA4AEL units. Sonnax now offers a reverse clutch drum sleeve, **73300-01**, that extends the life of the reverse clutch drum bushing journal and allows salvage of drums with worn or damaged bushing journals.

Salvage damaged reverse clutch drums by machining and installing the Sonnax pre-hardened steel sleeve.

- Pre-hardened steel sleeve is precision machined.
- More durable, wear-resistant bushing journal.
- Allows salvage of worn reverse clutch drums.
